Manhole Inspection Summary

Manhole # S33AA1033MH

Location Address: **3200 CHARLES ST**

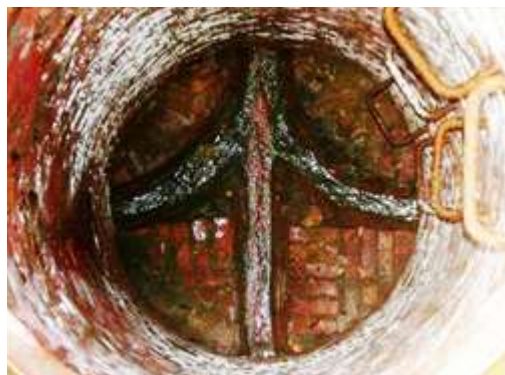
Top View

☐ Parged ☒ **Debris** (not Condition related)

Count: **6** Missing: **0** ☒ **Corroded**

Corroded steps. Bench debris.

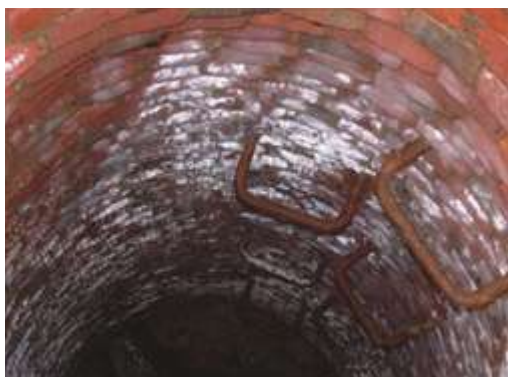
Defect

Infiltration: ☐ None ☒ **Joint** ☐ Cracks ☒ **Mortar** ☐ Roots ☐ Wall

Infiltration: ☐ None ☐ Joint ☐ Cracks ☐ Mortar ☐ Roots ☒ **Wall**

Adjustment, Corbel and Barrel infiltration.

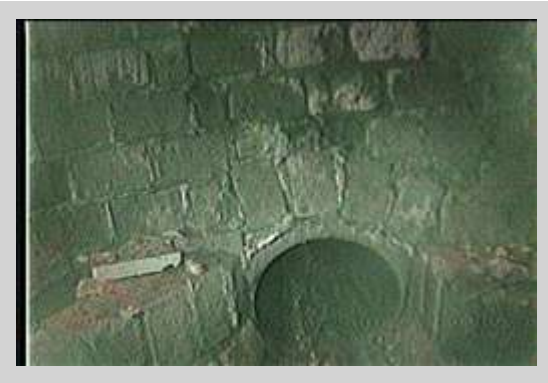
8 in. Circular Gravity Sewer Pipe Out @ 12 O'Clock

Condition: ☐ Sound ☐ Cracked ☐ Root Intrusion ☐ Loose Brick ☒ **Deteriorated**

Infiltration: ☐ None ☐ Joint ☐ Cracks ☒ **Mortar** ☐ Roots ☒ **Wall**

Barrel deterioration and infiltration.

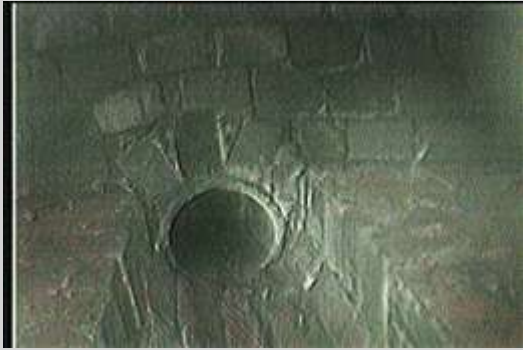
Pipe In @ 6 O'Clock

Infiltration: **Evidence**

Pipe Seal Cond: **Cracked**

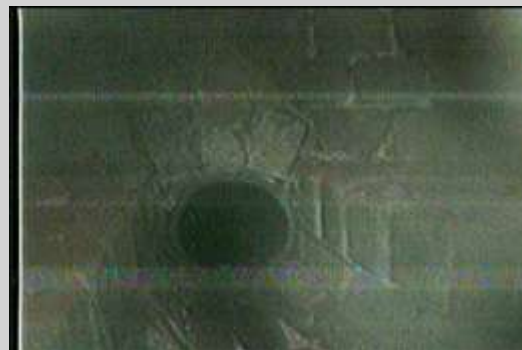
Drop In @ 8 O'Clock

Drop: **Outside** Rod and Bar
Angled: **Yes** Reading: **11.14** (ft.)
Inv Depth: **12.14** (ft.)

Drop Condition: **Open**
